Inspection Report
Minerals Regulatory Program
Date: December 9, 2008

Mine Name: Henefer Stockpiles	Permit Number: S/043/0011
Operator Name: Interstate Brick Company	Inspection Date: 12/04/2008
Inspector(s): Brett Gregory for Leslie Heppler <u>L</u>	Time: 12:00 PM
Other Participants: None	Mine Status: Inactive

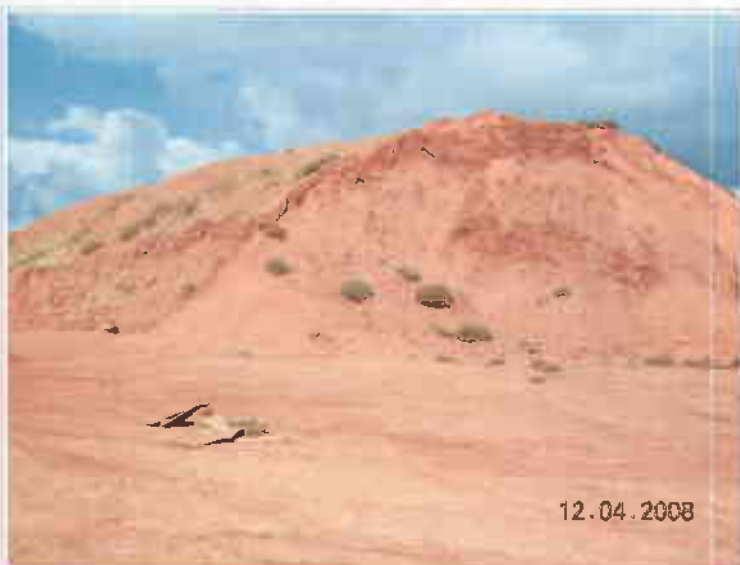
Stockpile highwall.

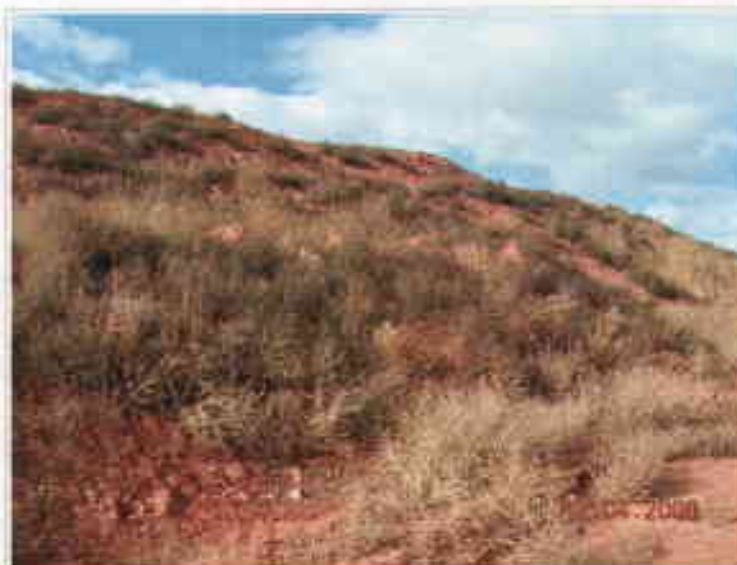
6) The previous inspection of this site had documented that the clay stockpile was from the landfill expansion by the county. It appears no more material has been added to this existing stockpile. Large amounts of Russian thistle have grown and only a small amount of clay has been removed on the east side (see photographs). Operator should consider controlling invasive weeds to help assure successful final revegetation efforts.

Russian thistle.

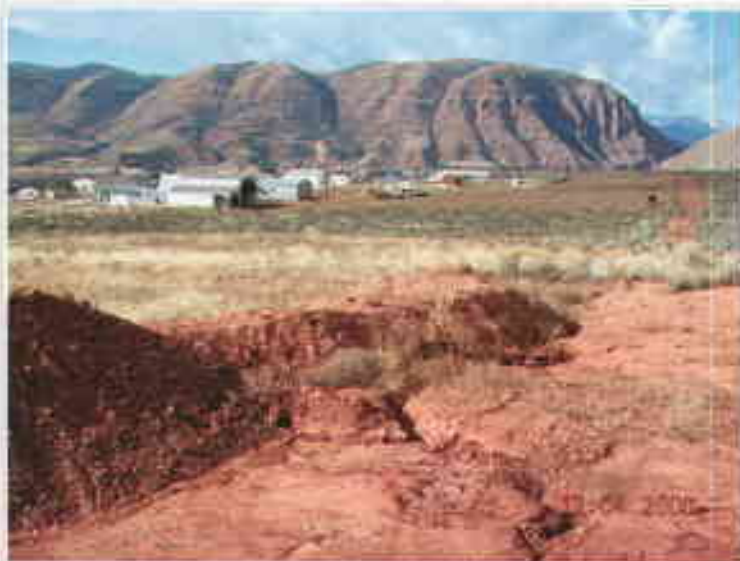
Rain runoff into the field – Operator to evaluate and remediate.

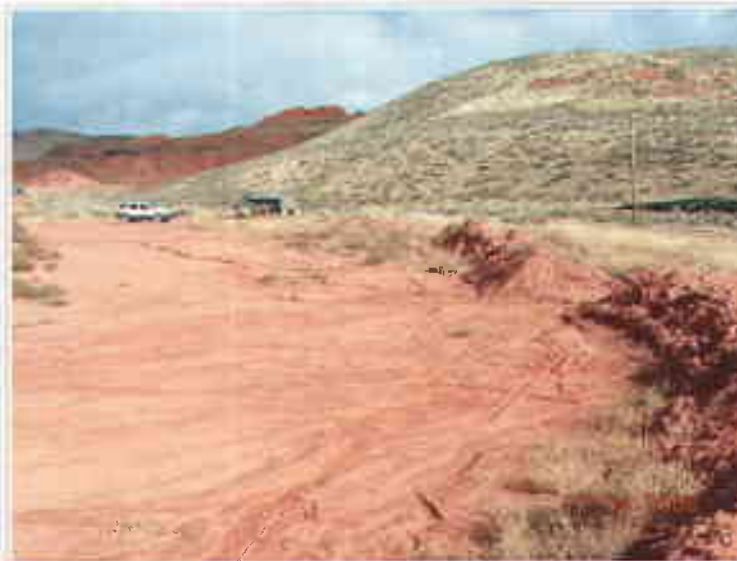
Berm has been breached.

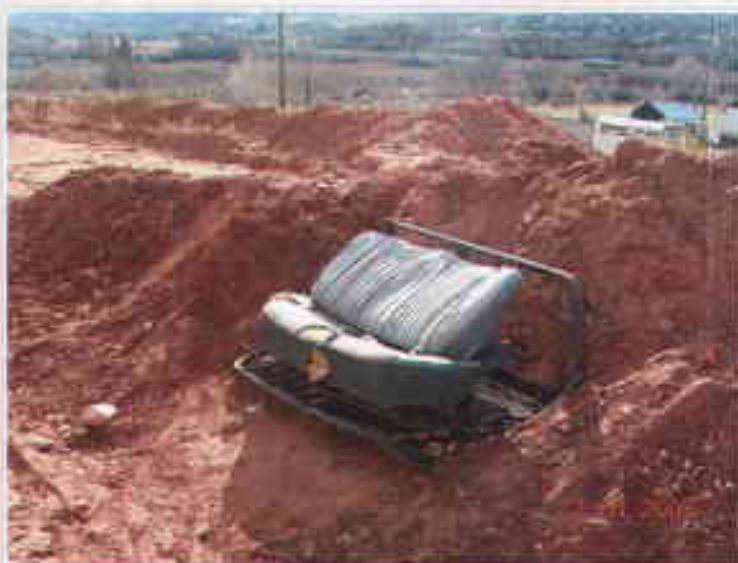
Garbage to be removed.

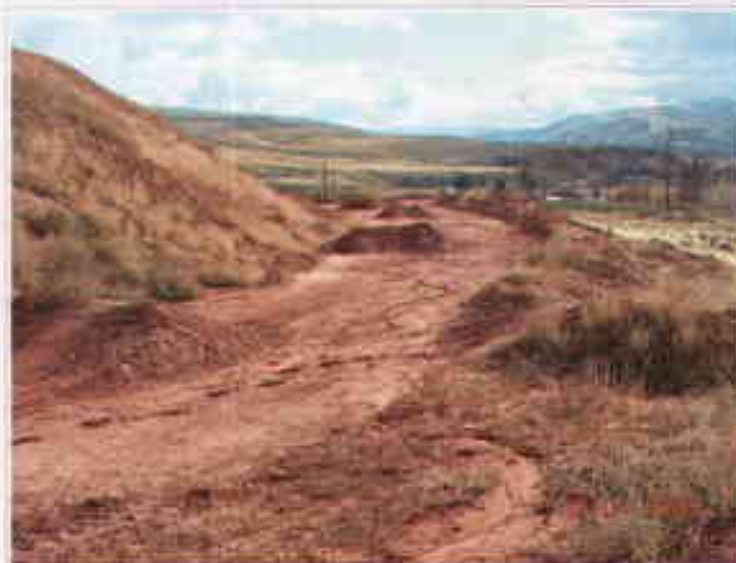
2) The bike jumps present a safety hazard and the operator should evaluate their liability.

Bike jumps that can be a safety hazard

Conclusions and Recommendations: Recommended that the operator post appropriate no trespassing signs to keep public out of the permitted area. DOGM will continue to monitor this site.

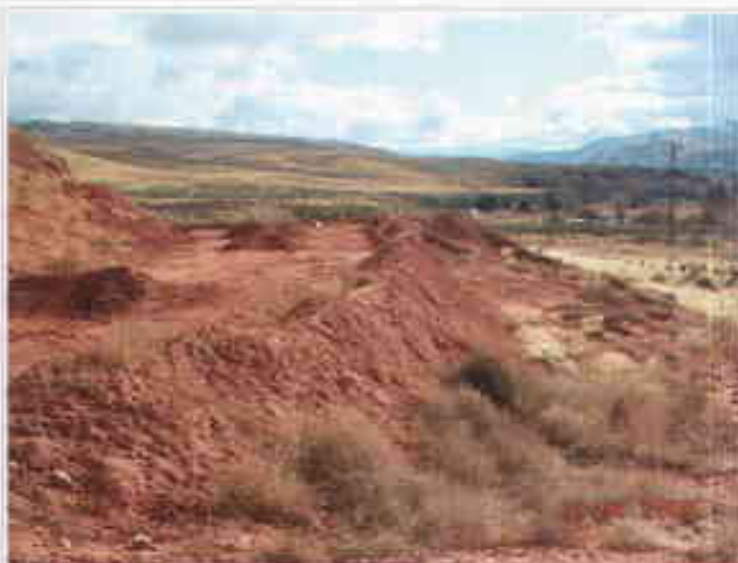
Southern berm.

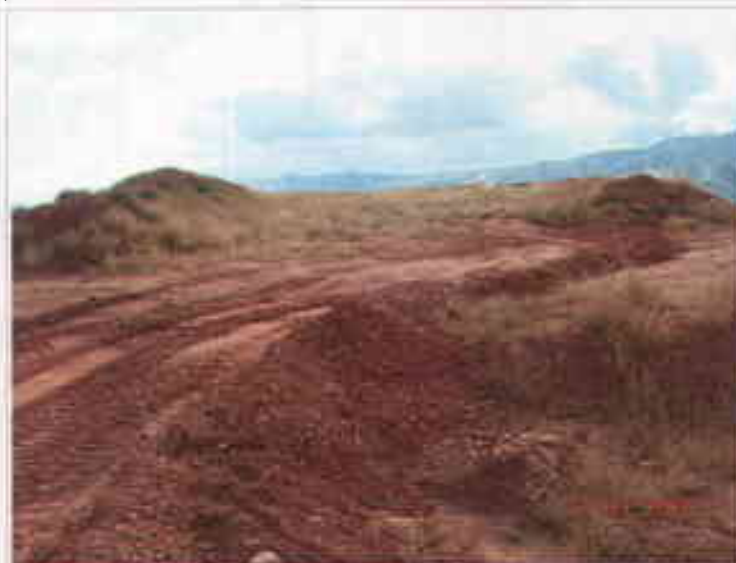
View of the top of the stockpile.
